THE ONTARIO POWER COMPANY OF NIAGARA FALLS

CONDITION OF CONDUIT NO. 1

AUGUST, 1922

WALTER J. FRANCIS, C. E.

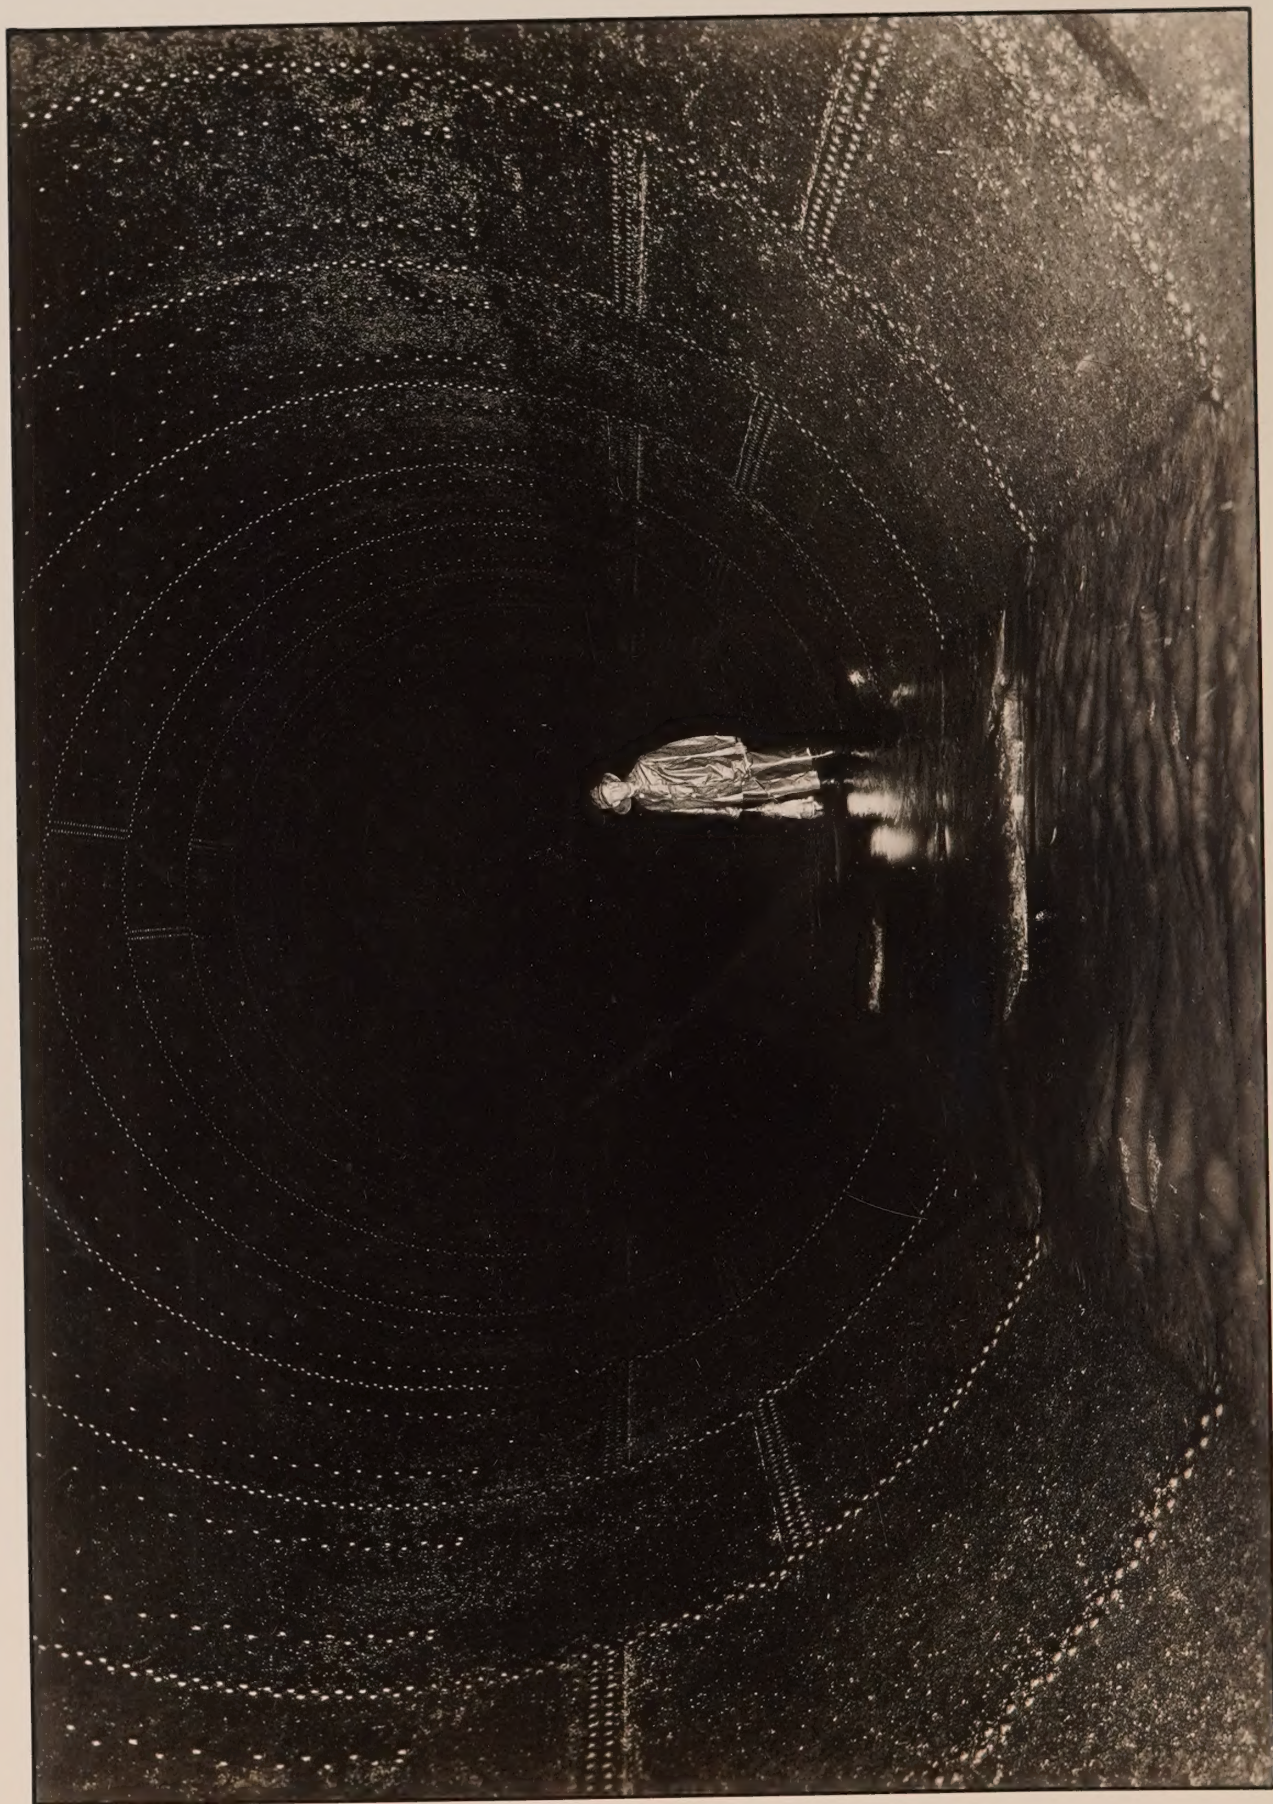
(b)

Interior of Conduit No. 1.

General Conditions at Time of Inspection

on August 6th, 1922.

Photograph taken by flash-light looking towards the Head Gate.

We had flashlight photographs taken as a record. The picture included as a frontispiece shows the general condition clearly.

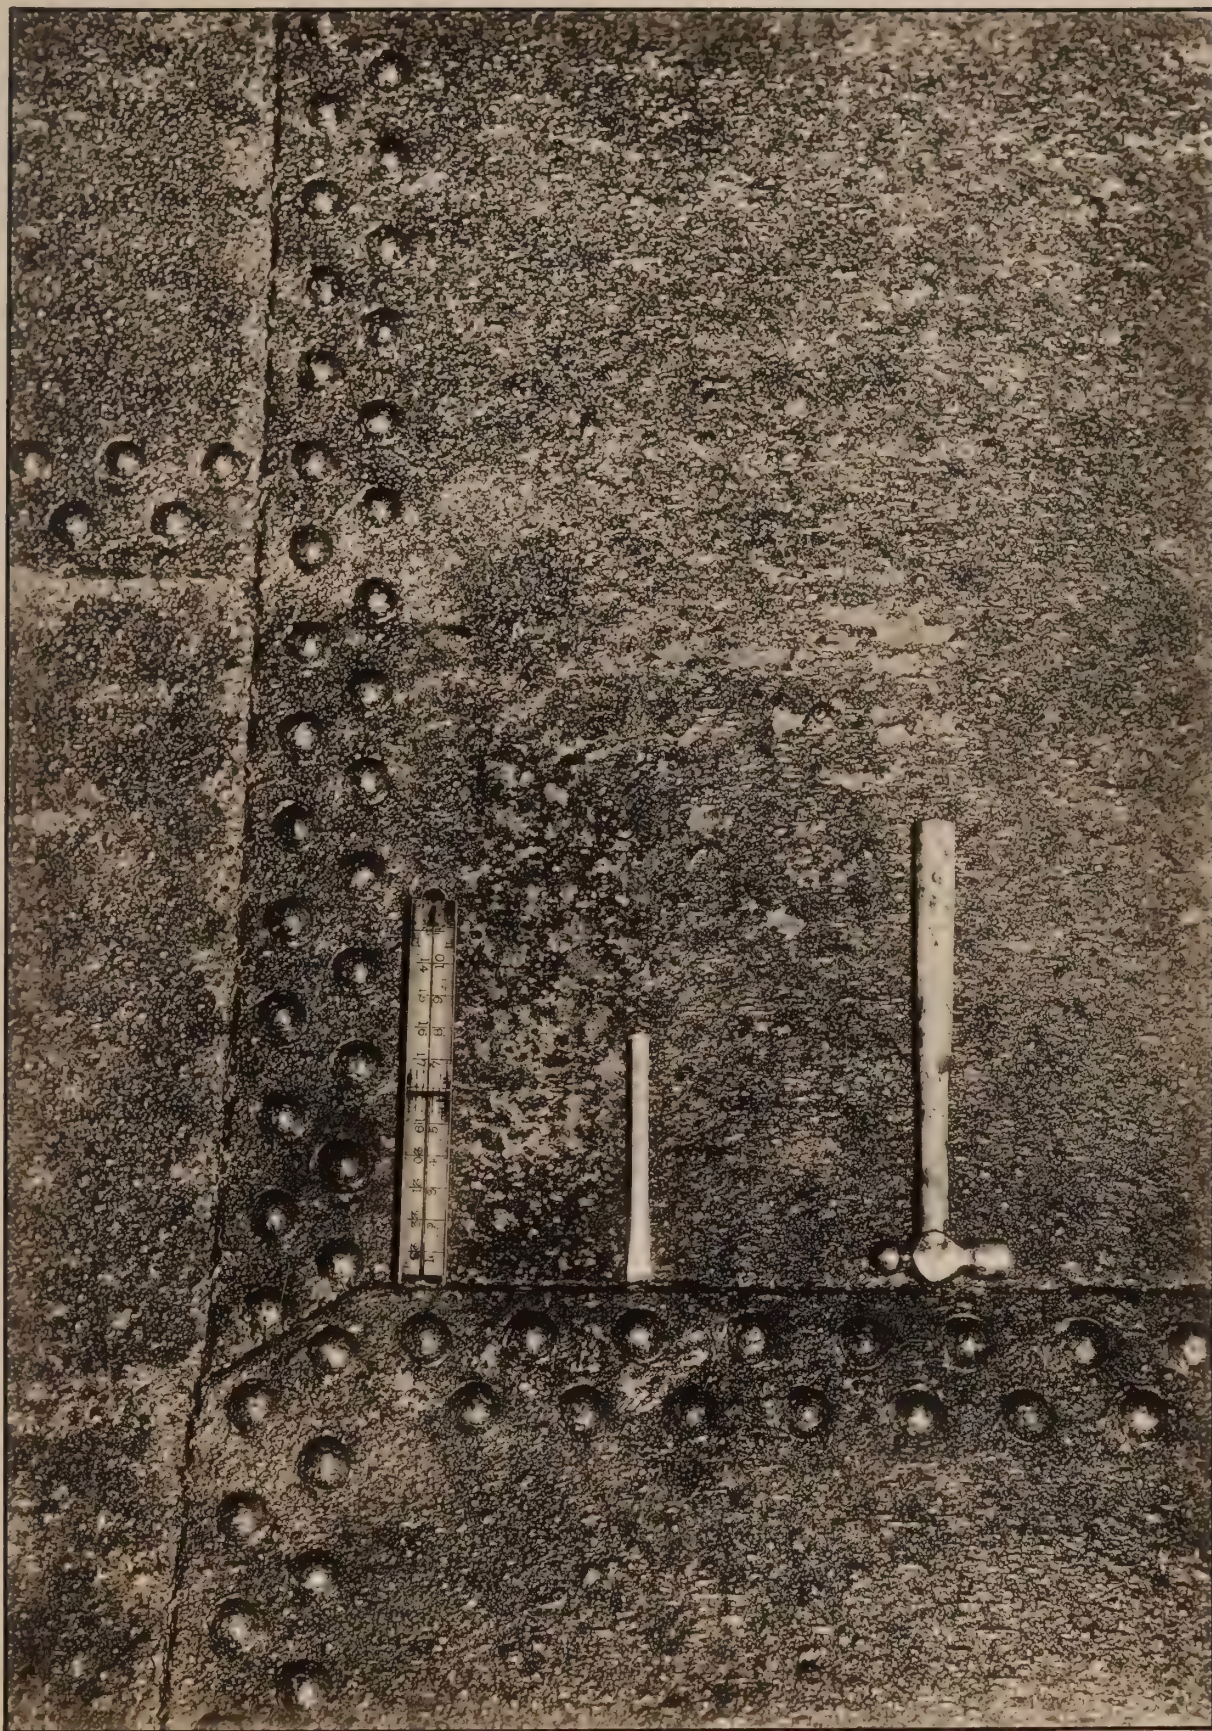
COPY FOR ENCLOSURE TO Mr. J. Allan Ross.
To face page (6).

thickness, and in some cases more. Upon removing this deposit from the surface with a knife blade, no trace of pitting of the steel was found, but there is a general oxidation one one-hundredth of one inch or possibly one sixty-fourth of one inch in depth. This applies to the rivet heads as well as to the plate. On the whole the surface is in excellent condition.

The photograph included herewith as page 8 shows in clear detail the condition of the surface of the interior of the pipe. A portion of the surface of the steel between the rule and the chisel, as well as a rivet head three inches above the bottom of the rule and two others near the bottom of the chisel, were scraped and rubbed carefully. The balance of the surface within the field of the picture is as we found it. Along the caulking edge of the plates may be seen some of the calcareous incrustations. Certain of the large formations in the picture are also incrustations. The mill surfaces of the steel plate may be readily identified in the lighter colored, even-looking areas. The high lights in the picture, as for example the tops of the rivet heads, result from the use of the flash-light, and are not to be interpreted as polished surfaces.

Interior of Conduit No. 1.

Detail of the Surface

August 6th, 1922.

Photograph taken by flash-light.
